Theme :	MY21 U5 1.5.0 software upgrade service action		
Vehicle :	U5 EU	Release :	2020.11.13
MY :	2021	Effective :	2020.11.20
Bulletin No. :	US-ST-A18-20-009	Range :	LVXMAXBA3LR900532 to LVXMAXBA9LR900633 (250 vehicles)
Marketing :	EU	Replace :	None

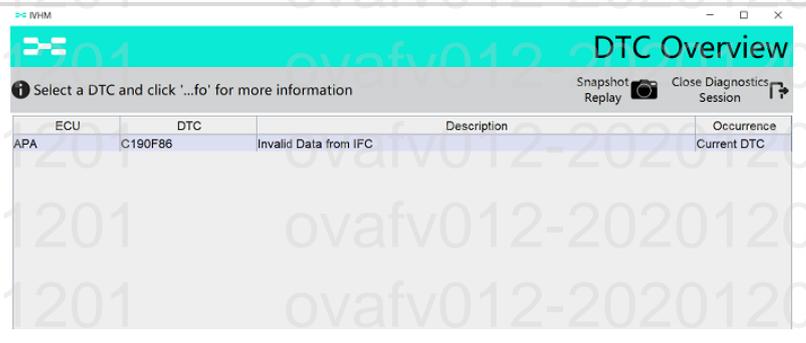
16. Clear all the DTCs of vehicle;
 Note:
 a. If APA Report **C190F86 Invalid Data from IFC** Can be ignored.
 b. If IFC report **C1B4A96 FCR not support required destination**
 Please do vehicle configuration validation.

DTC	ECU	Name	Solution
C190F86	APA	Invalid Data from IFC	Ignore or vehicle fall asleep
C1B4A96	IFC	FCR not support required destination	Do vehicle configuration validation
