Theme :	MY21 U5 1.5.0 software upgrade service action		
Vehicle :	U5 EU	Release :	2020.11.13
MY :	2021	Effective :	2020.11.20
Bulletin No. :	US-ST-A18-20-009	Range :	LVXMAXBA3LR900532 to LVXMAXBA9LR900633 (250 vehicles)
Marketing :	EU	Replace :	None

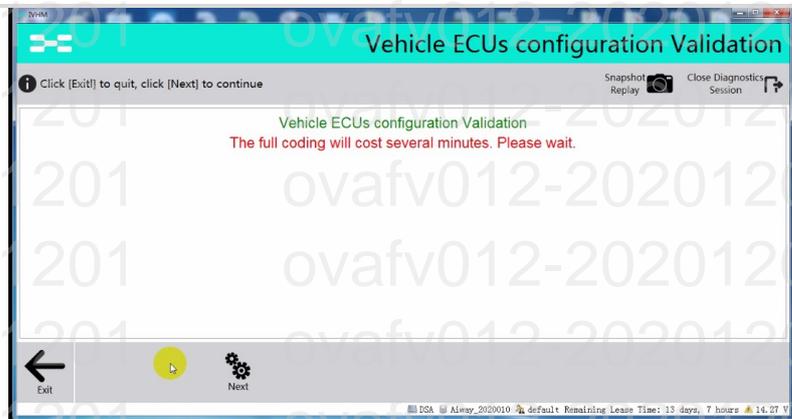
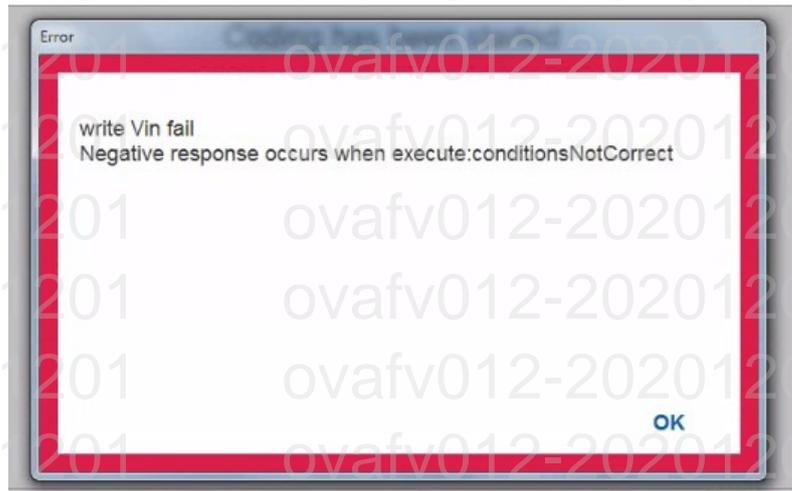
- a. Ignore the VIN fail, if it occurred in Coding
- b. If IVI coding failed, it caused by the 12V battery disconnect. Try to recoding in the service and calibration interface, Select "configuration function" and "vehicle configuration validation" in the page;
